**Lower Mattole River Fish Habitat Improvement**  
**Project**  
**Final Report**  
**USFWS Cooperative Agreement with**  
**Mattole Salmon Group**

Agreement #81331AJ148  
Cover Page

Project Start and end dates: 6/30/10 to 2/28/11

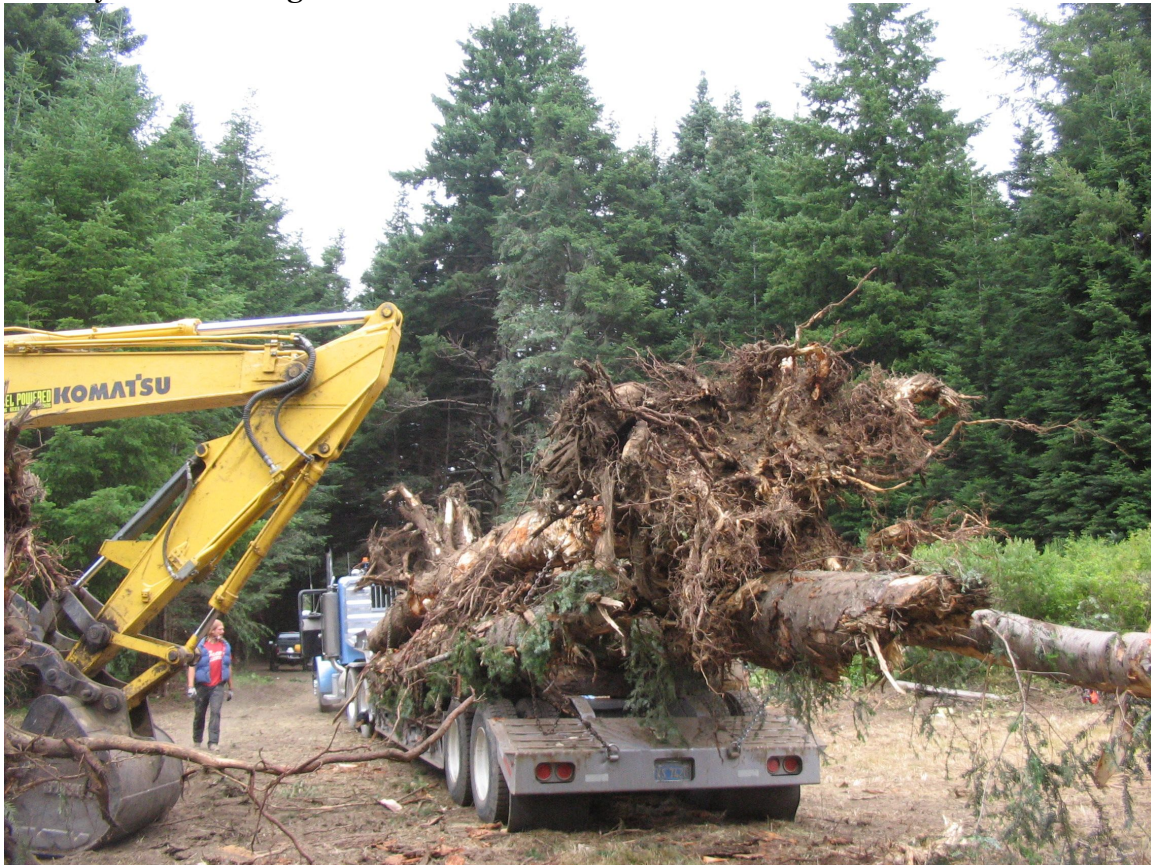
Figure 1, Low-bed ready for haul to Project Deck A

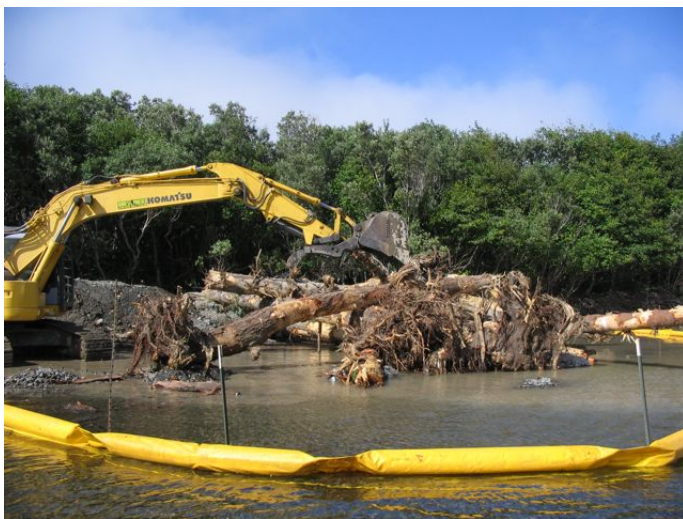
Figure 2 LWD structure #5 under construction

The excavator opened up machine access to each of the specific sites. A siltation baffle was installed and the excavator began placement of the boulders. Wood was placed on top of the boulder foundation (see Figure 2.). Once the downstream structure was constructed (approx. 2 days of excavator work) the excavator moved to the up-stream site. Our ground crew moved the siltation baffle and construction began in the same manner.

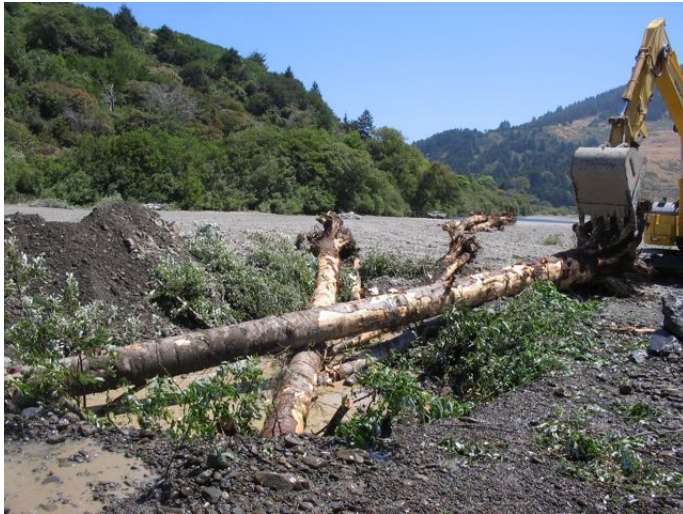
Figure 3 Apex jam under construction

The sites for the four apex jams was on the north bank of the river (see map **Error! Reference source not found.**Figure 8). The loader transported the logs across the river, and the excavator began constructing the jams. The jams were constructed by using a minimum of four large pieces of wood each (40+ foot long pieces with root-wads). The root-wads were placed up-stream and the body of the log was buried downstream (see Figure 3).

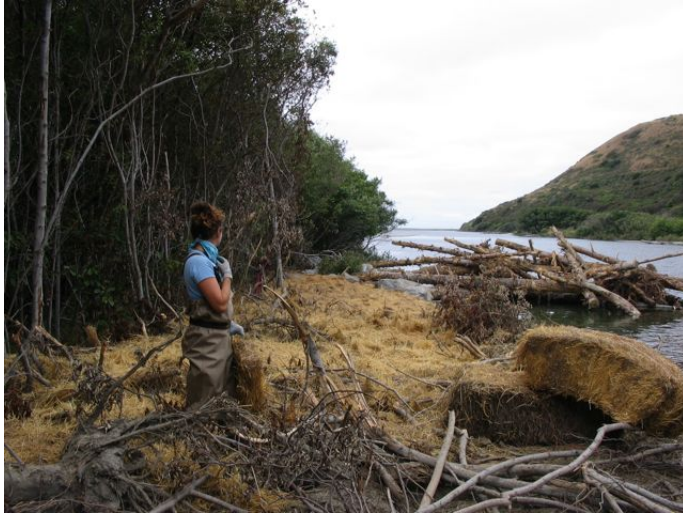
Figure 4 Mulching disturbed sites after construction

All in-stream work, including hand work of anchoring the structures was complete by August 17, 2010. Crews then hauled native grass straw to the site and mulched all areas disturbed by equipment. Note: willow and cottonwood were planted during construction with the assistance of the excavator. Planting of rooted alder trees took place in January 2011. Volunteers from the local high school in under the leadership of the Mattole Restoration Council planted the alder trees in the areas above the water line in disturbed areas.

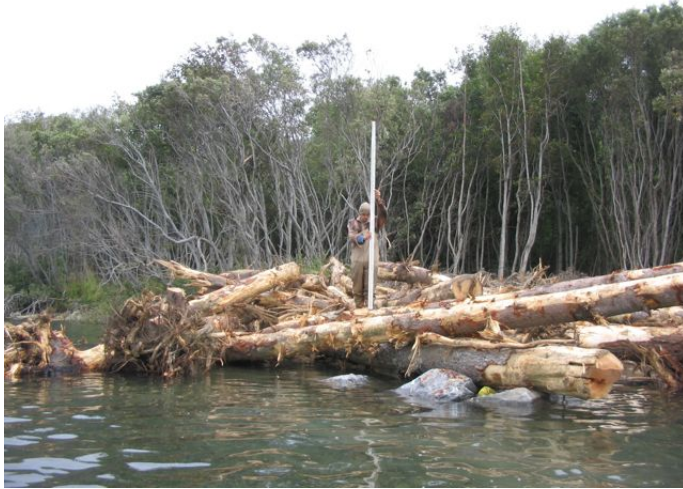
Figure 5 LWD Elevational survey

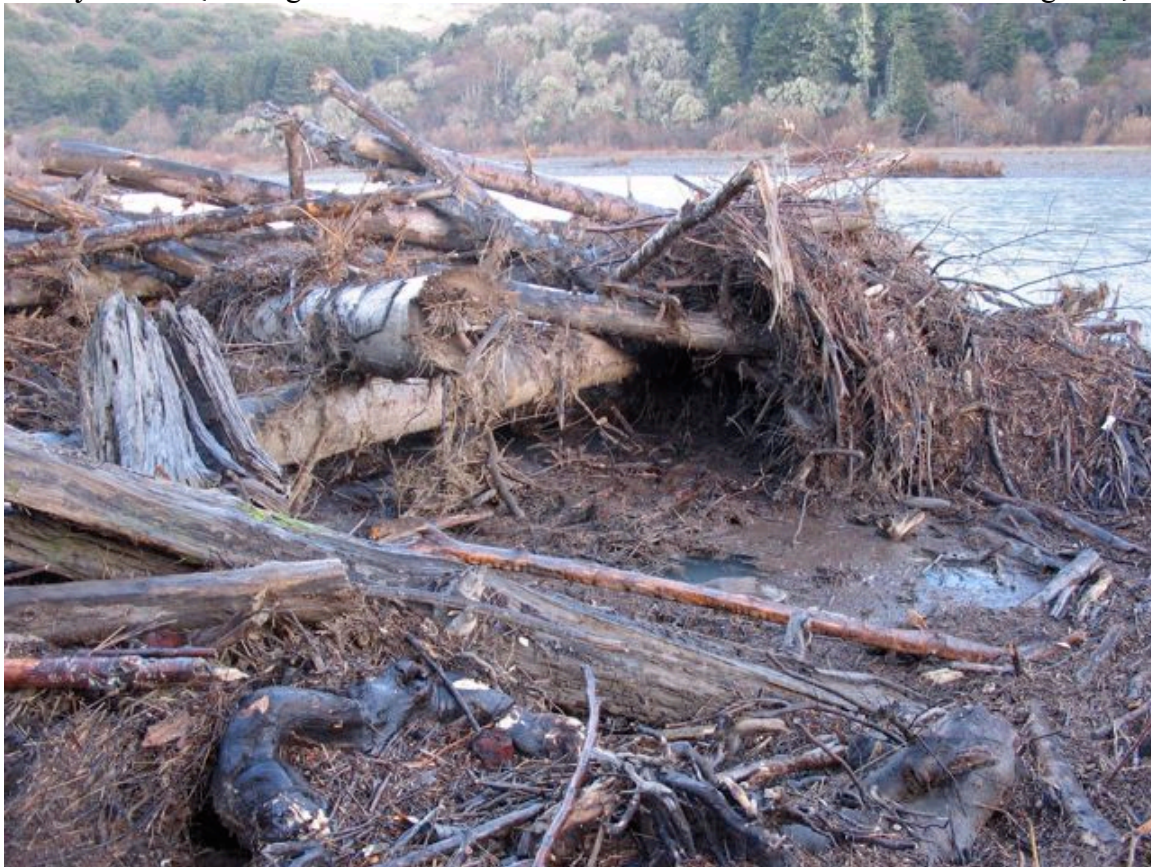
All project sites were observed and photographed throughout the winter to observe effects of flow and structure integrity. Our observations showed complete structural integrity of LWD structures, and a large accumulation of woody debris (see Figure 6 and **Error! Reference source not found.**Figure 7)

Figure 6 LWD structure #5 after flows

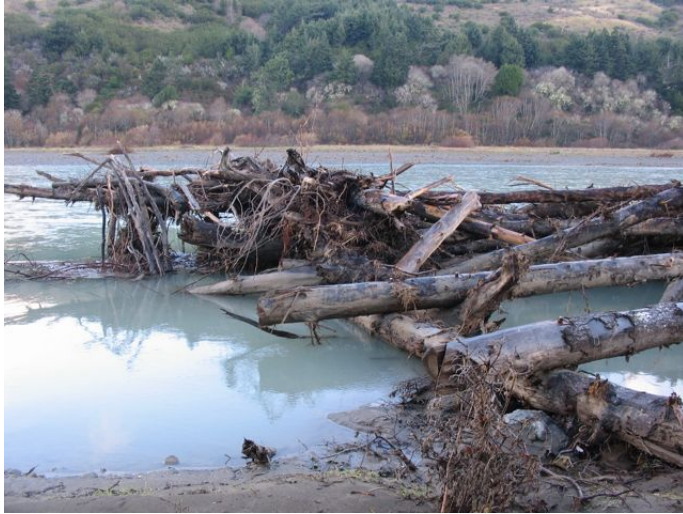
Figure 7 LWD structure #6 after flows
