The status of this project is complete. During this reporting period all field aspects of the project took place and were completed.

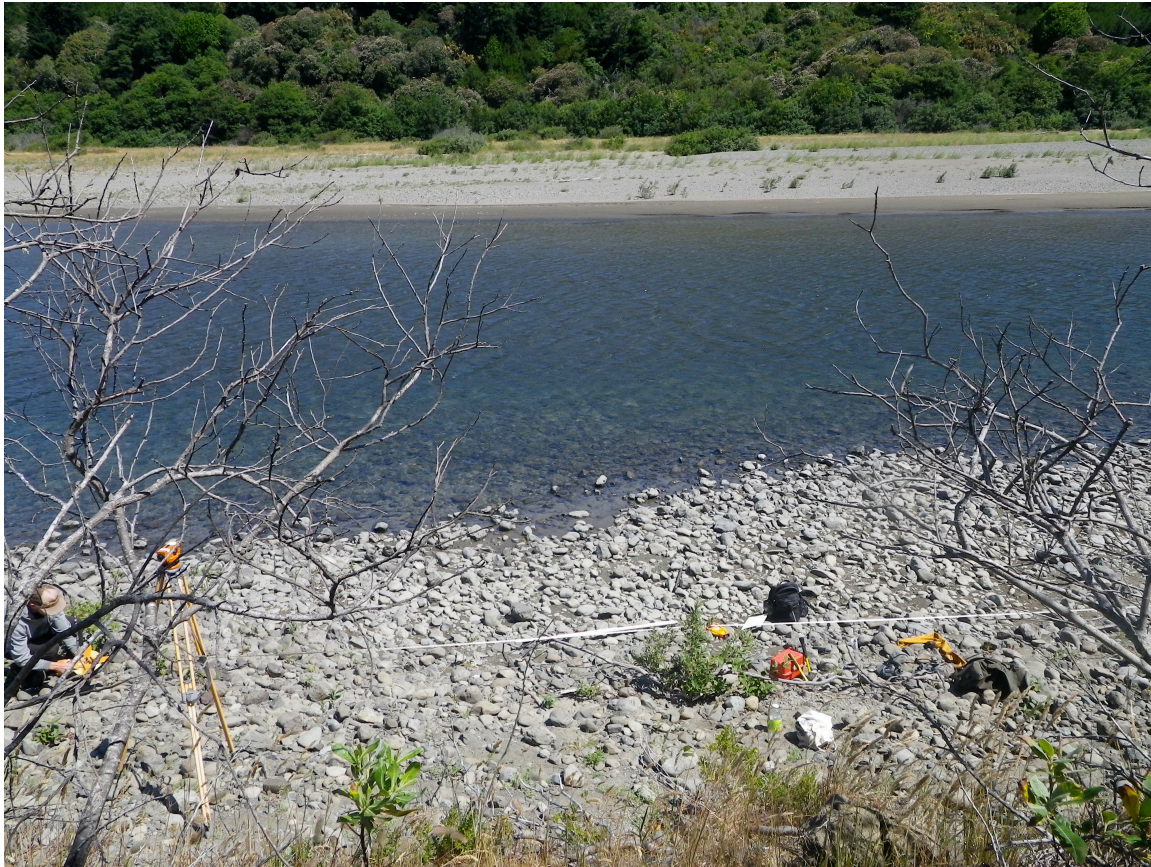
Photo 1. Pre-project photo showing conditions and survey of area. July 2011

Pre-project photos were taken on July 25th 2011 (see attached photo 1.).

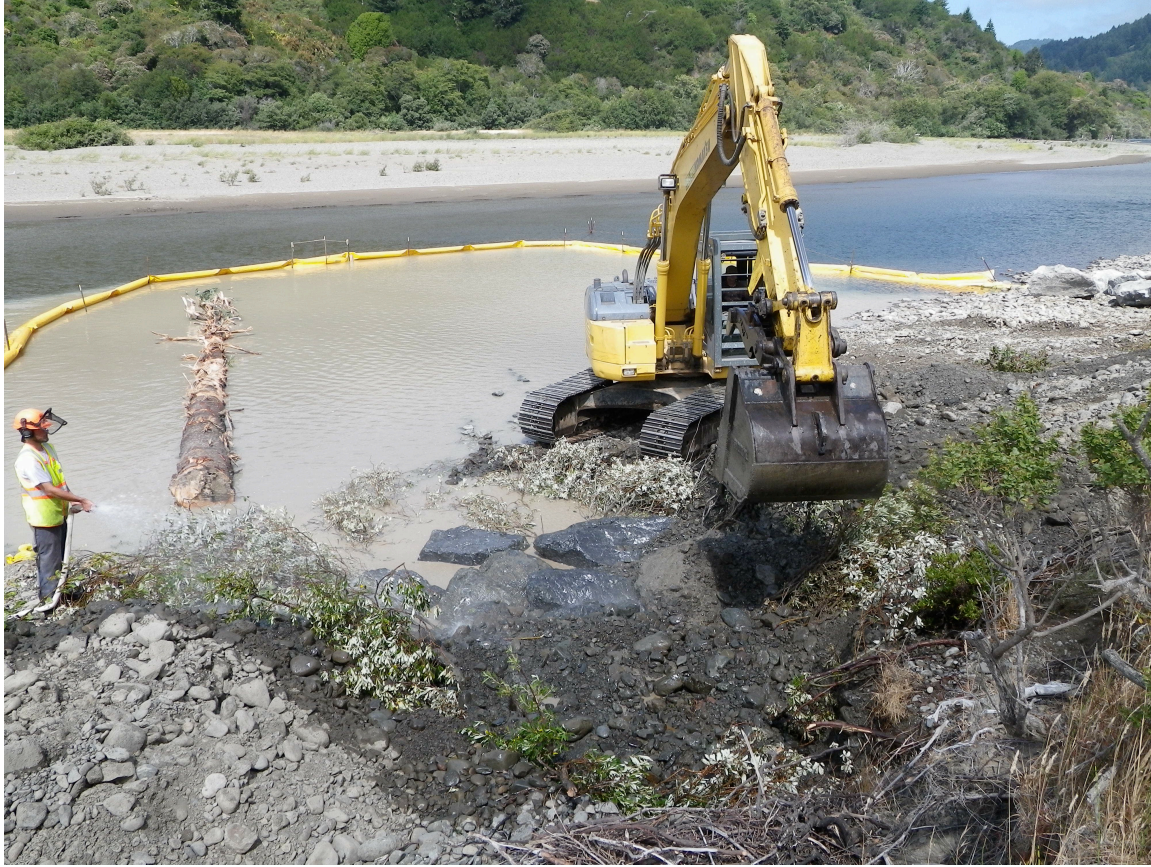
Photo 2. Construction in progress, August 2011

LWD construction – August 11th to August 17th. During this period, the access road was created, structure constructed and access road removed (see photo 2).

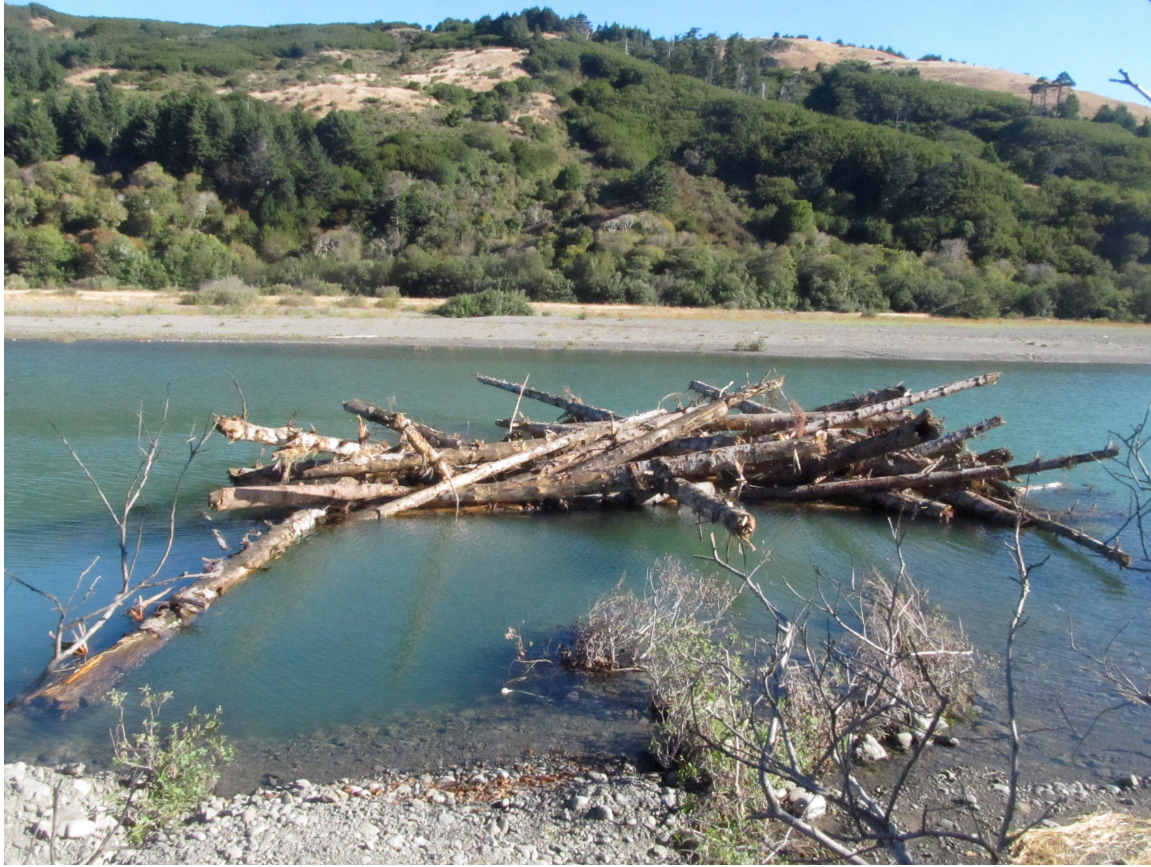
Photo 3. The Completed LWD structure August 2011

Upon completion, the disturbed areas were mulched and watered, and all anchored connections were double checked to ensure

completion (see photo 3).
